SANACIJE I REKONSTRUKCIJE ROTORNIH BAGERA REPAIR AND RECONSTRUCTION OF BUCKET WHEEL EXCAVATORS

REPAIR AND RECONSTRUCTION OF OPERATING WHEEL ON EXCAVATOR C700 O&K (OPEN-CAST MINE KOLUBARA LAZAREVAC)

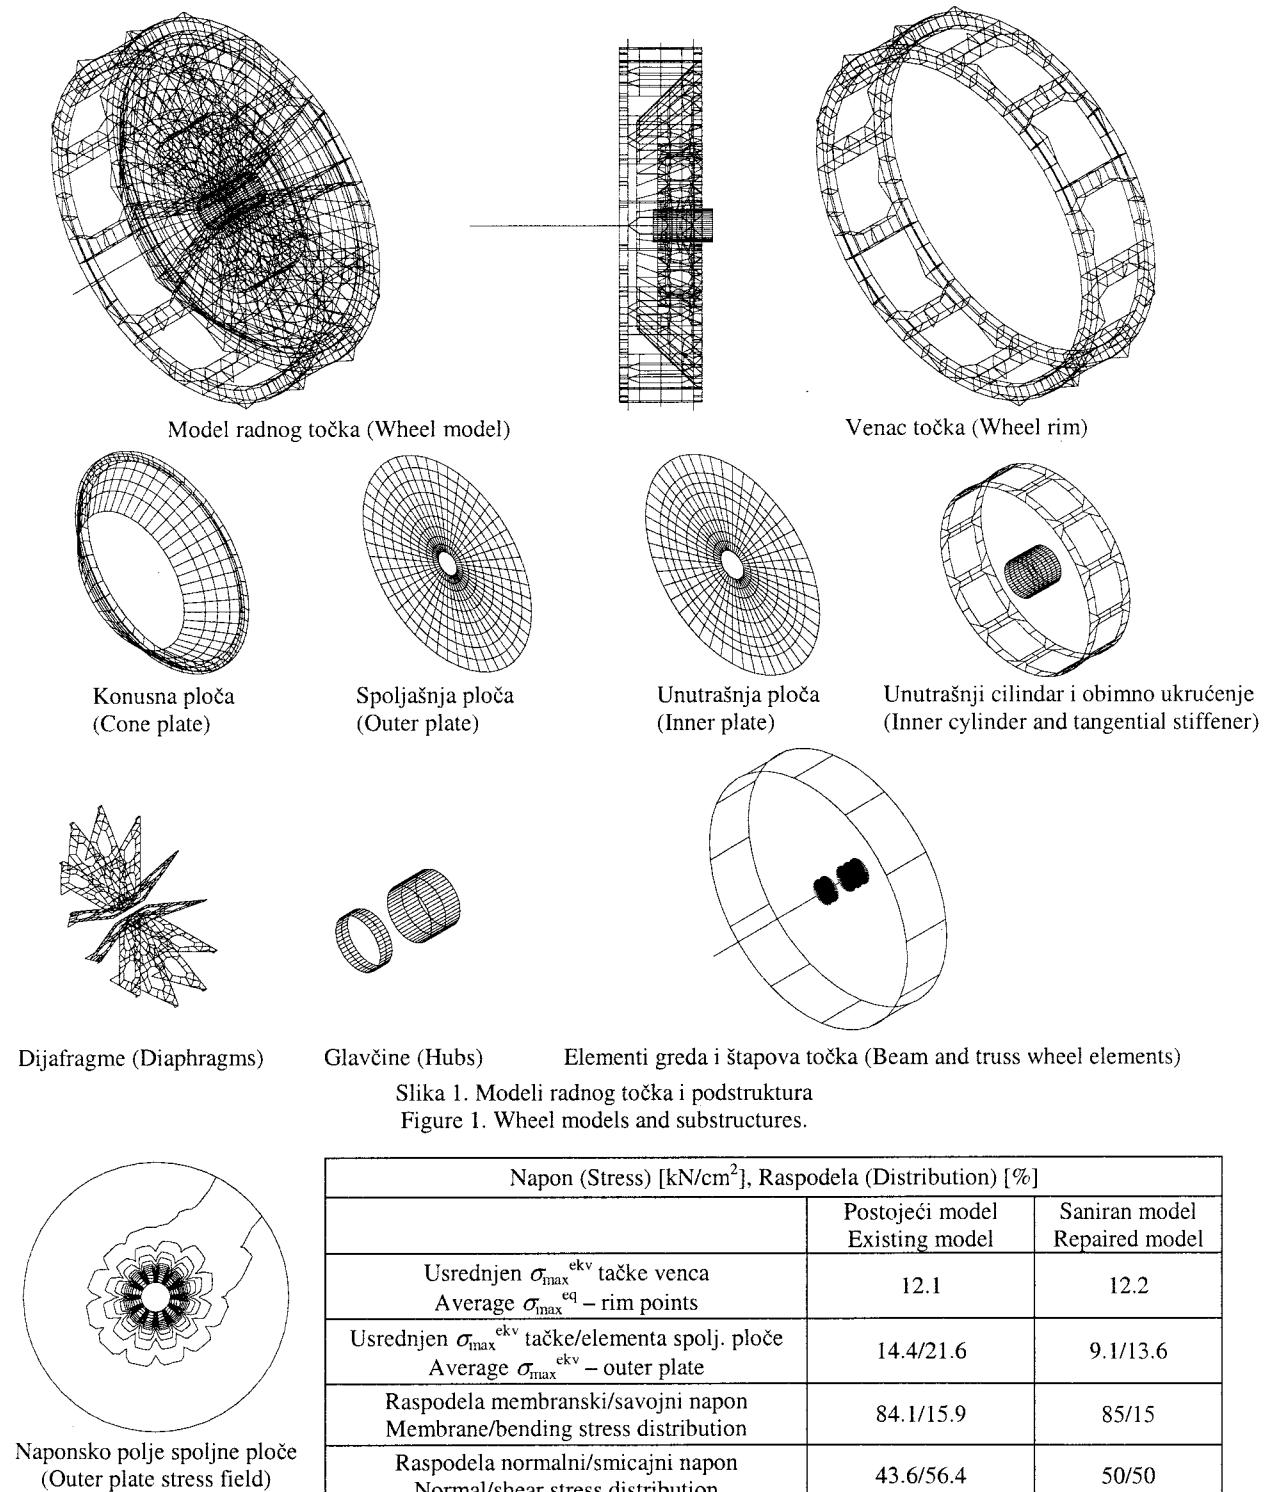
Slika 1. Modeli radnog točka i podstruktura
Figure 1. Wheel models and substructures.

The following operating wheel loads are approved: circumferential force 232.7 kN; lateral force 65.9 kN, per bucket. The discretized operating wheel model, shown in Fig. 1, consists of 409 linear elements and 2952 plate elements. The operating wheel failed in service, causing cracking of connected plates and shafts. The stress fields and distributions are shown in Fig. 2.

The distribution of normal and shear stresses indicates large presence of shear stresses. Membrane stresses are dominant. The analysis undoubtedly shows that the failure is caused by insufficient thickness of the outer plate.

Adding a ring of increased thickness (2 cm instead of 0.8 cm) to the outer plate led to significant stress decrease (from 21.6 to 13.6 kN/cm²) and also to a decrease in the shear stress effect. The wheel has continued to operate successfully.

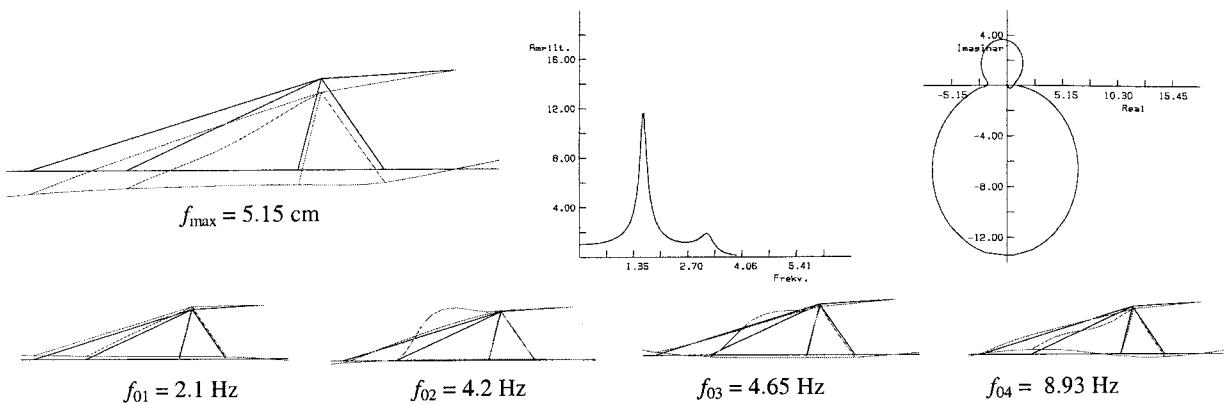
Slika 6. Rezultati statičkog i dinamičkog proračuna rekonstruisane strele
Figure 6. Static and dynamic numerical results of the reconstructed cantilever.

During excavator service life, poor dynamic behaviour of the unloading beam is frequent, i.e. with resonant oscillations, amplitudes up to 60 cm. This may result in cracking of certain cantilever elements. The structure consists of one beam element and three truss elements (tie, yoke and cylinder).

Cantilever reconstruction meant adding two new ties, yoke reinforcement and removal of heavy elements (cameras were placed) (Fig. 5). Numerical results and model are shown in Fig. 6. The cantilever operates successfully. Acceleration measurements were made on the reconstructed beam and ties. Figure 8 shows a measured signal. As can be seen, the acceleration is below the allowed value (2 m/s^2) and with no response of cantilever eigen-frequency.

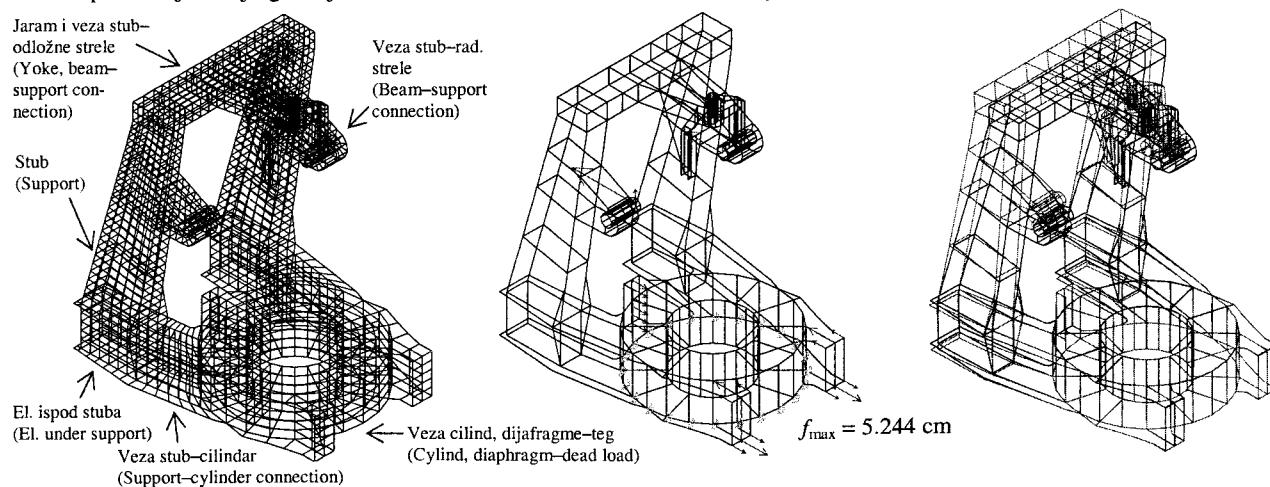
Slika 8. Računski model gornje gradnje bagera sa najnepovoljnijim opterećenjem i deformacijom
Figure 8. Numerical model of upper excavator assembly with worst case load and deformation.

The analysis is aimed in determining and resolving cracking causes of support and cylinder connection and poor dynamic behaviour of upper assembly. Upper assembly numerical model and strain pattern with worst loading case are shown (Fig. 8). Upper element strength diagnostics and detailed analysis of lower assembly behaviour are shown below.

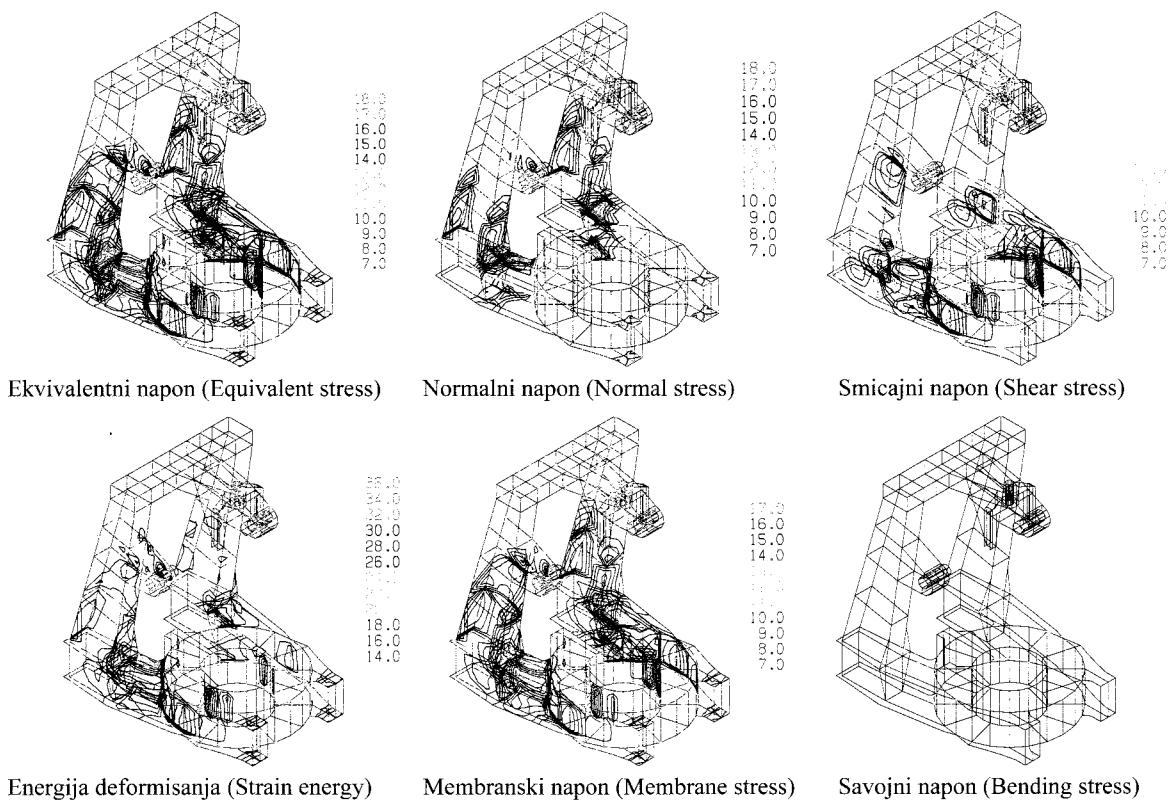
Slika 10. Raspodela napona [kN/cm^2] i energije deformisanja [kNm] rekonstruisane gornje gradnje
 Figure 10. Stress [kN/cm^2] and strain energy [kNm] distribution of reconstructed upper assembly.

- support–cylinder connecting elements have the largest stress, stress concentration, and strain energy,
- support and cylinders have a low stress level on a large surface with a high contribution of stress and energy,
- the yoke has the least significant effect on the behaviour.

Inproper upper assembly behaviour can be corrected by increasing thickness of upper and lower horizontal plate connecting elements. An upper plate thickness increase of 15 mm, i.e. a total of 39 mm was approved, while lower plate thickness was increased 10 mm (34 mm total). The maximum strain value is now $f_{\max} = 4.669$ cm. Figure 10 shows strength diaghnostics of reconstructed upper assembly elements, and Fig. 11 shows the reconstructed assembly.

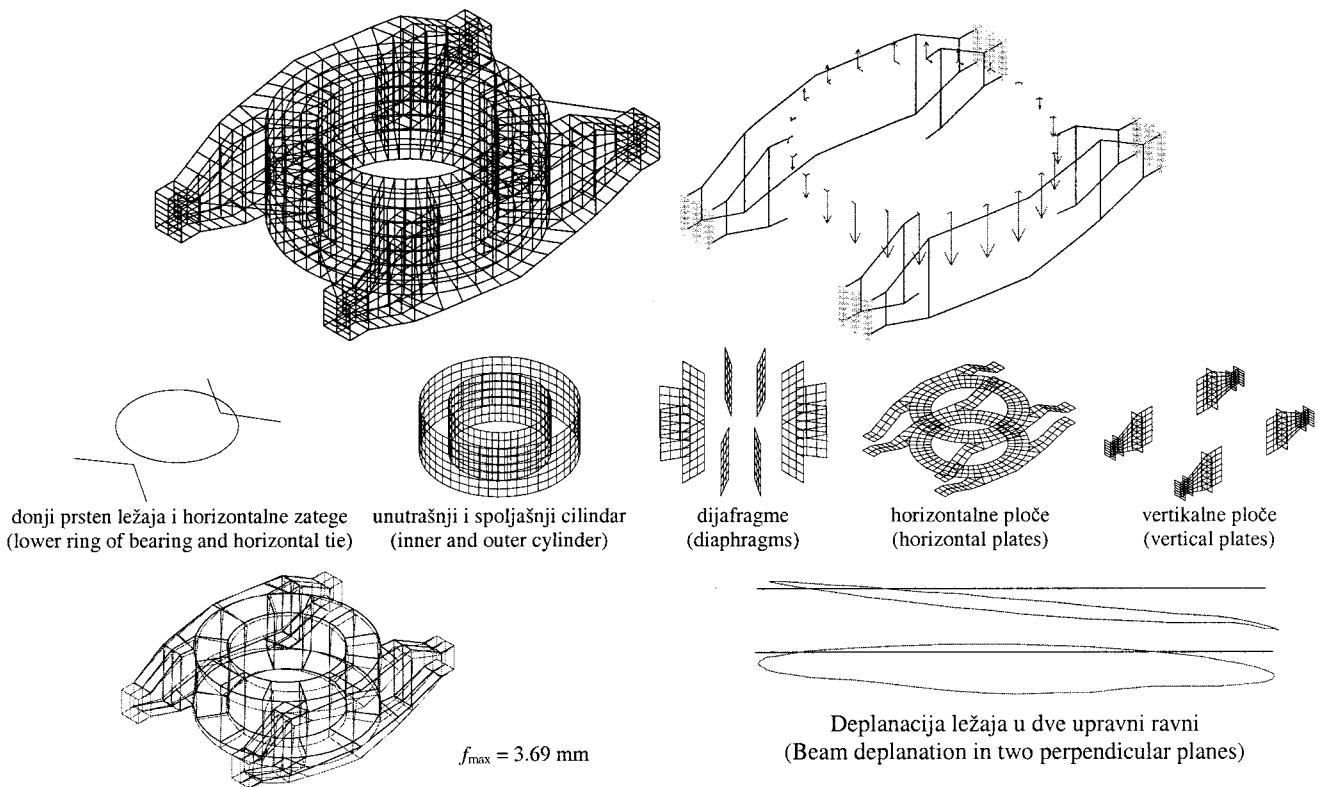
Slika 13. Računski model i deformacija
Figure 13. Computational model and deformation.

The excavator lower assembly suffered several partial and complete cracking of assembly connection beams (see Fig. 12). Model and numerical results are shown in Fig. 13 and 14. Table 2 shows the analysis of the old and new solution.

Inappropriate lower assembly structural behaviour can be repaired by adding vertical plates. Behaviour would also be significantly improved by increasing horizontal plate and cylinder thickness, but this is technically not reasonable.

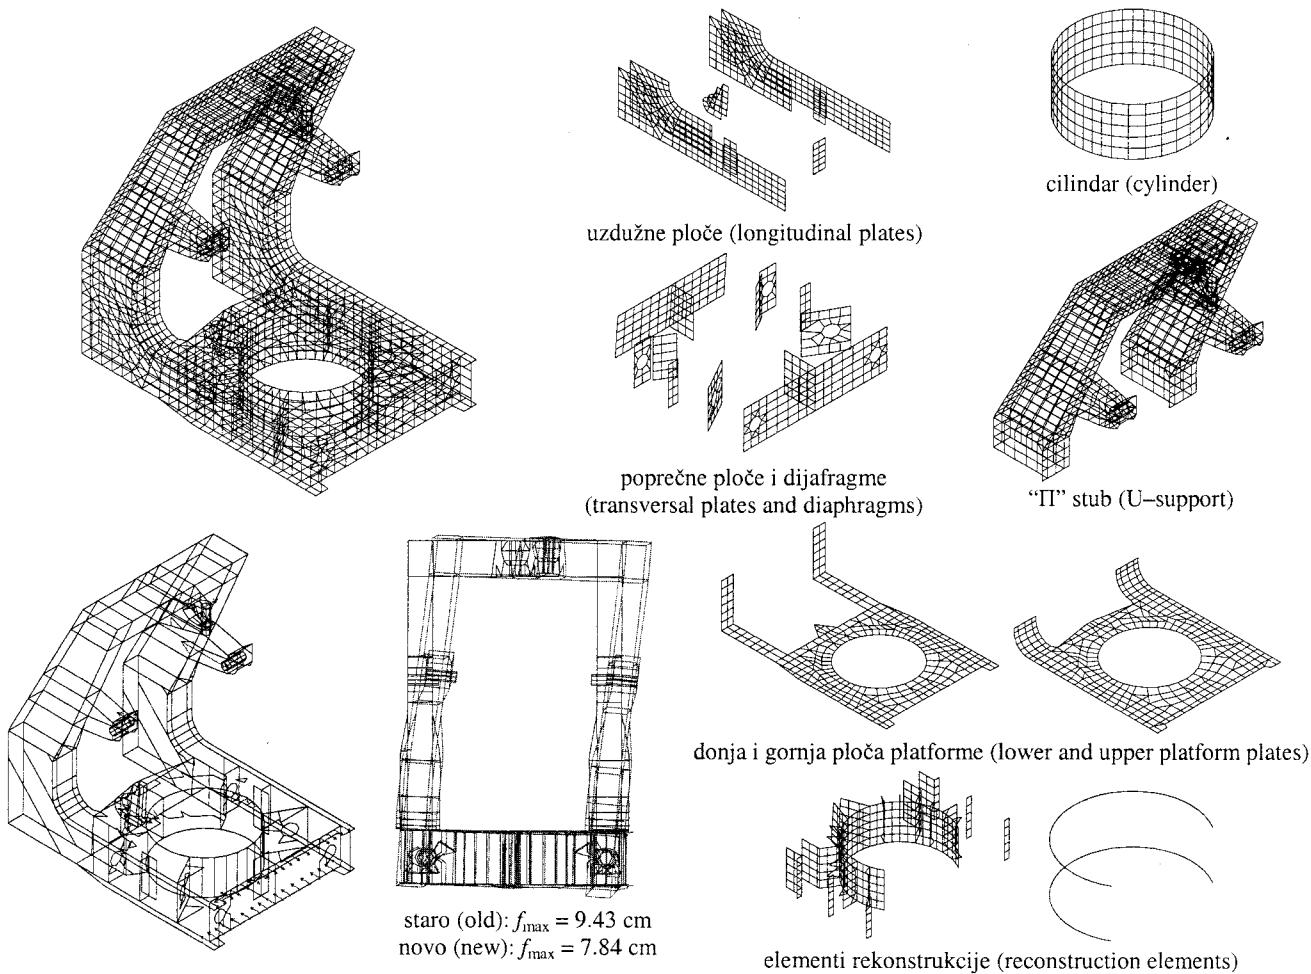
Slika 16. Model gornje gradnje bagera, njegova deformacija i elementi rekonstrukcije
Figure 16. The upper assembly structural model, its strain and reconstruction elements.

The excavator suffered constant cracking in the lower assembly. The hindering crack in the cylinder-lower horizontal plate joint was 2 m long. Also, cracks appeared at the top of support. Determining causes for cracking requires detailed structural strength diagnostics of the upper assembly for all dynamic loading cases. The computational model, worst load case, deformed structure pattern and reconstructed elements are shown in Fig. 16. Stress and strain energy distributions are given in Fig. 17. The reconstructed upper assembly is shown in Fig. 18.

Diagnostics conclude the following: large strain, very high level of stress and its concentration, high normal membrane stress and strain energy appearing in the same location. Such behaviour makes the problem easier to solve.

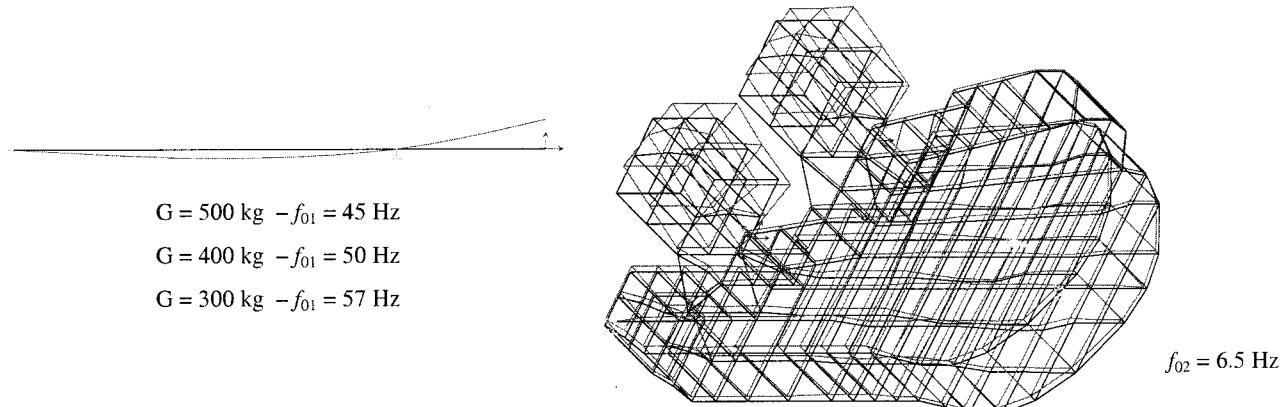
Slika 21. Dinamički model ulaznog vratila i reduktora sa motorima
Figure 21. Dynamic model of the driving shaft and transmission with motors.

The numerical model of the driving shaft and first form oscillations with coupling weight affecting its eigen-frequency value is shown in Fig. 21. The coupling weight has a very negative effect on first eigen-frequency (the coupling must be lighter than 400 kg). A reduced numerical dynami-

cal model of the whole transmission with motors, as well as the second form of oscillations are shown in Fig. 21. This model confirms negative effects of the motor's vertical oscillation that occur at many other frequency values.

Successful transmission operation in the following four months (until replacement for other reasons) was achieved only by increasing the rigidity of transversal motor beams. It was impossible to replace the coupling with a lighter one.

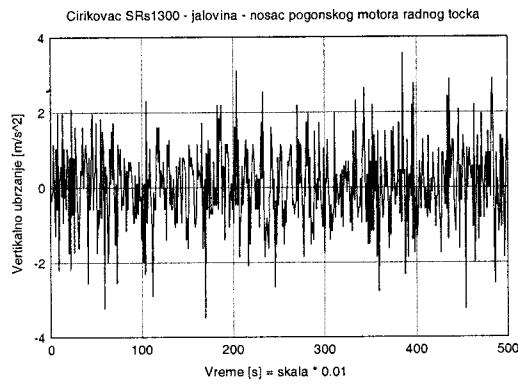
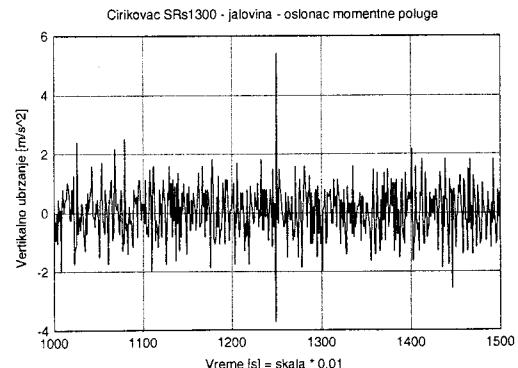
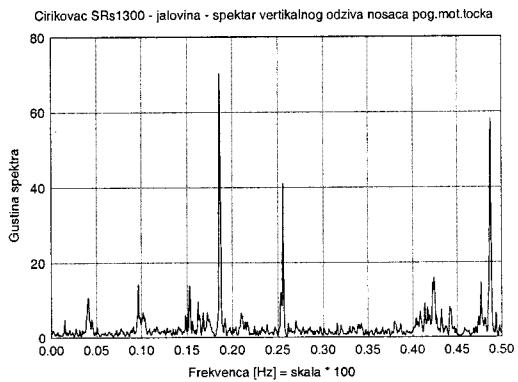
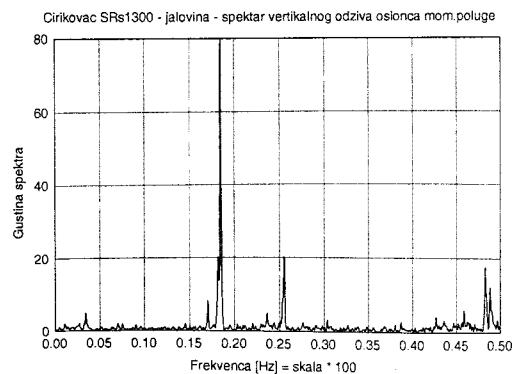
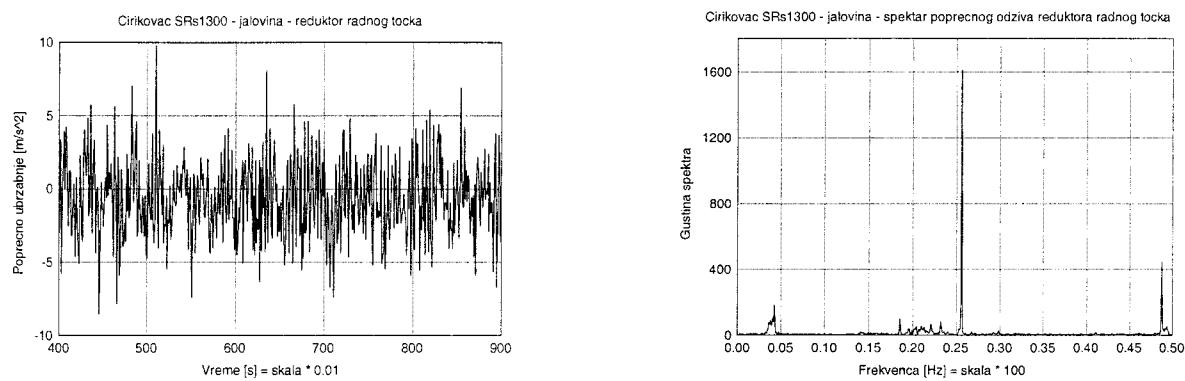
Figure 27. Transversal acceleration in time (left) and spectrum density in frequency domain (right).

Comment on measuring: the accelerations overpasses allowed values ($a_{dmax} = 2 \text{ m/s}^2$); the response of the digging system is a strong signal at frequencies 3, 4, 12, 14, 18, 25, and 49 Hz, and slightly weaker at frequencies 2, 5, 7, 9, 13, 15, and 23 Hz, and these frequencies are tightly correlated to the induced and eigen frequencies of digging transmission, i.e. the transmission may easily approach resonancy in operation. This transmission had suffered failure. This type of transmission had failures and still has operating problems also at other basins. This confirms that poor behaviour is identified. Replacement, or global revitalisation of the digging transmission is recommended.

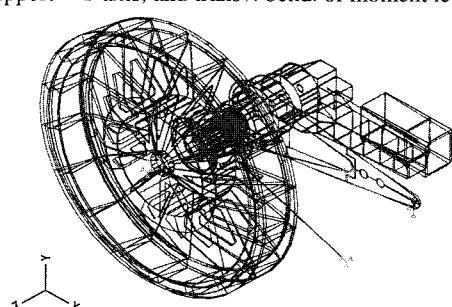
Slika 31. Glavni oblici oscilovanja sistema za kopanje
Figure 31. Main oscillation forms of the digging system.

$f_{014} = 18.4 \text{ Hz}$ – savij. radnog točka, savij. nosača motora oko Z ose (bend. of operating wheel, bend. of motor support – Z axis)
