ASSESSMENT OF THE FATIGUE BEHAVIOR OF REPAIRED ALUMINUM CARBODY STRUCTURE

Abstract – Aluminum carbody structures vs. steel structures have an increasing share in rail vehicle passenger fleet. New trams for Belgrade city transport with aluminum carbody structure after approximately three years of service, suffered from cracks. The first repair made by manufacturer was only partially successful. Two years after repair some cracks reappeared. This paper deals with some specificity of the aluminum structures repair process. The issue of the aluminum structures fatigue is compared with the fatigue of common carbody steel structures. Stress measurements in the repaired welding zone after second repair and reinforcement are presented. The test was performed with fully loaded tram under typical service conditions. Assessment of the future fatigue behavior is made based on the analysis of measured data.

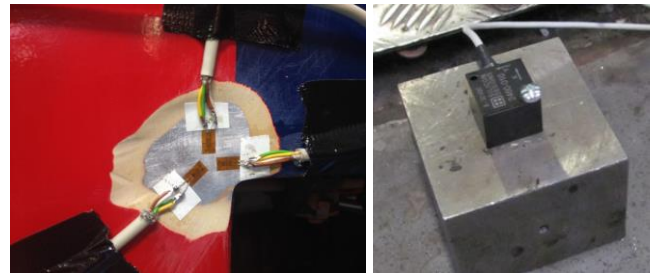
Fig.5. Measurement sensors

At one corner of bogie cut in the lateral side of carbody, in the immediate vicinity of the repaired weld, was performed measurement with strain gauges in 0/45°/90° rosette arrangement (Figure 5a). At two other corners the measurement was made with strain gauges placed perpendicular to weld. The strain gauges HBM 6/120LY13 for aluminum measurement with 6 mm base were used.

Three-axial acceleration measurements were performed with SD2460-010 pickup placed on the floor with the aim to correlate the appearance of high stresses to acceleration amplitudes. In this way, stress causes like curve passing, acceleration, braking, vertical or lateral track irregularities could be identified.

a) strain – gauges b) accelerometer
