# 'Design-in' Faults - the Reason for Serious Drawbacks in High Capacity Bucket Wheel Excavator Exploitation

<sup>1</sup>University of Belgrade - Faculty of Mechanical Engineering

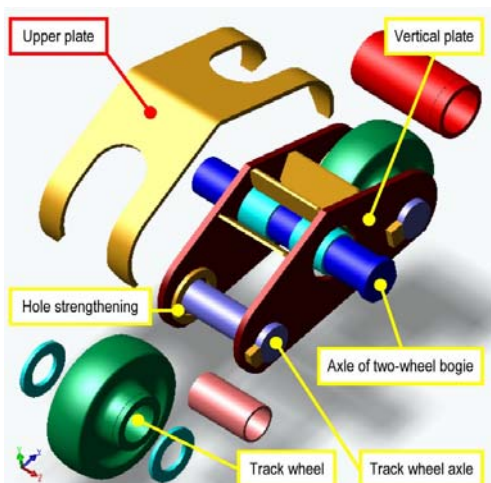
Figure 5: 3D model of the bucket wheel excavator Krupp 1760 TWB

Fig. 5 shows the main TWB subassemblies. It can be observed that there is no connection between the vertical plates in the TWB structure under the hole for bedding the track wheel axles. On the other hand, based on the looks of the TWB damaged structure, shown in Fig. 2, it is conclusive that the main cause of its failure is insufficient strength during the action of lateral forces which are dominantly applied during the BWE curve travel [5]. The verification of this conclusion is done by applying the linear FEA.

The authors of this paper strongly suggest the conservative approach to calculating the TWB structure, using models which do not include the track wheel axles, since it provides sufficient TWB carrying capacity even in the case of unforeseen loads, the appearance of which is quite possible having in mind the extremely hard working conditions.

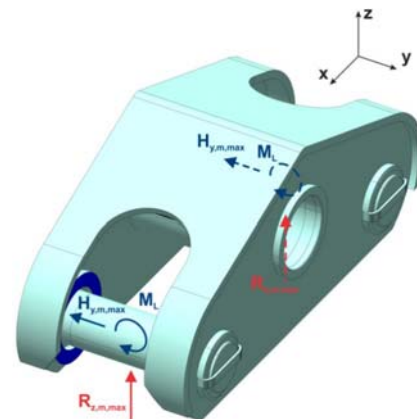
Figure 6: Loading of the TWB structure model which includes the track wheel axles subassemblies

In order to simulate the behaviour of the TWB structure predefined by the project documentation, a model which includes the track wheel axles was analyzed. Lateral forces act on one vertical plate - annular surfaces of the holes' strengthening, blue coloured surfaces, whereas track wheel axles are loaded by vertical forces and bending moments ( $M_L$ ) gained by a reduction of lateral forces, Fig. 6.

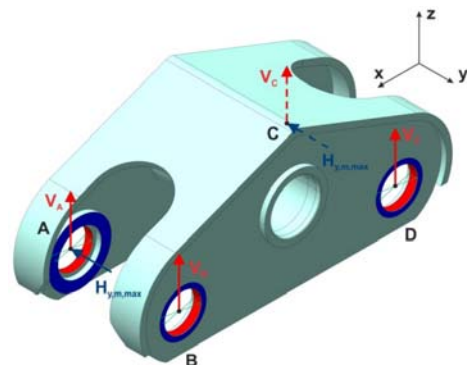
Figure 7: The TWB structure loading in case of an axial gap between the vertical plate and the track wheel axles subassemblies

One of the main problems detected in the process of defect inspection was, as previously stated, shearing of the axle nut, which leads to the appearance of a relatively great axial gap between the TWB vertical plates and the track wheel axle subassemblies. In this case, an FE model was created by supposing that the lateral forces act only on one vertical plate, while the second is the support in the corresponding direction, Fig. 7.

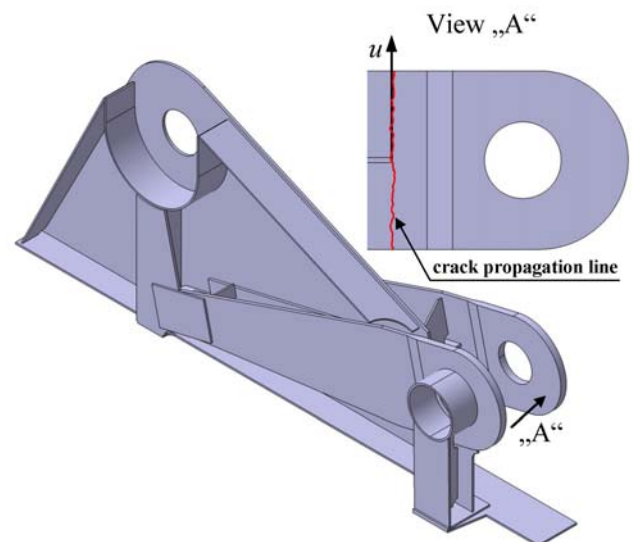
Figure 9: 3D model of the support of the right portal tie-rod

The portal tie-rods supports, Fig. 9, are the vital parts of BWE structure. By means of tie-rods (rope diameter 110 mm), they accept a part of the BWB and portal loads and transmit it onto the counterweight boom. At the same time they are supports of the rope system drum for BWB hanging. The straightforward cause of BWE collapse, as it was previously stated, is the failure of the end eye connection of the support of the right portal tie-rod (Fig. 4).

- Due to the prompt incursion of the lengthwise supporting plate into the eye structure and the proximity of the location where the load is applied, the pronounced stress concentration occurs in the failure zone of the eye;

The high stress state of the designed support structure of portal tie-rods, conjugated with the detrimental effects of the welding seam (not welded through root, porosity, inclusions) perpendicular to the force direction, as presented in [10] and dynamic character of loads, is the principal reason of the end eye connection failure and the BWE collapse.
