List Saveza energetičara
Broj 1-2 / Godina XVIII / Mart 2016.
UDC 620.9

Miodrag Arsić, Zoran Savić
 Institute for materials testing, Belgrade, Serbia
 Srđan Bošnjak, Vlada Gašić
 Faculty of Mechanical Engineering, Belgrade, Serbia
 Dušan Arsić
 Faculty of Engineering, Kragujevac, Serbia

State Analysis of Components of the Damaged Structure and Integrity Evaluation of Braces at the Spreader A2Rs - B 5500.55 + BRs

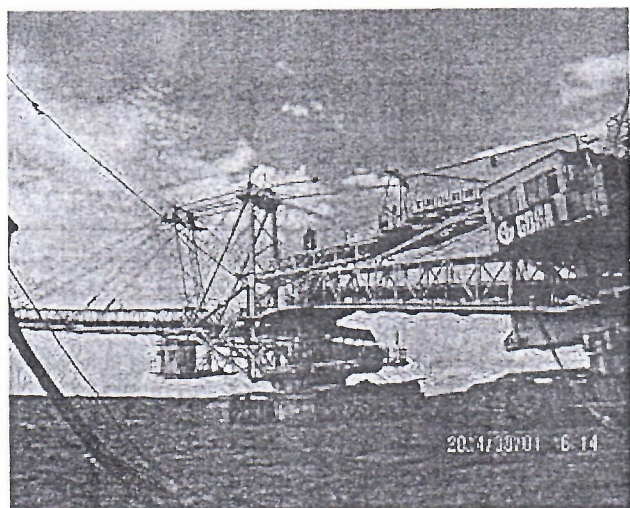
Figure 1.- Appearance of the spreader A2Rs - B 5500.55 + BRs before and after the breakdown

Spreader A2Rs - B 5500.55 + BRs before and after the breakdown is shown in *figure 1*. Breakdown of components of the vital lattice structure which occurred due to the uncontrollable sliding of the machine during the tempest which needed to be made from scratch is marked in *figure 1b* and shown in *figure 2*, while the state of braces in assembled condition is shown in *figure 3*. Some of the braces at which no damage was detected are shown in *figures 4a* and *4b*, while one of them at which the surface crack was detected on parent material, in the near proximity of the welded joint, is shown in *figure 4c*.

a) Appearance of the spreader before the breakdown

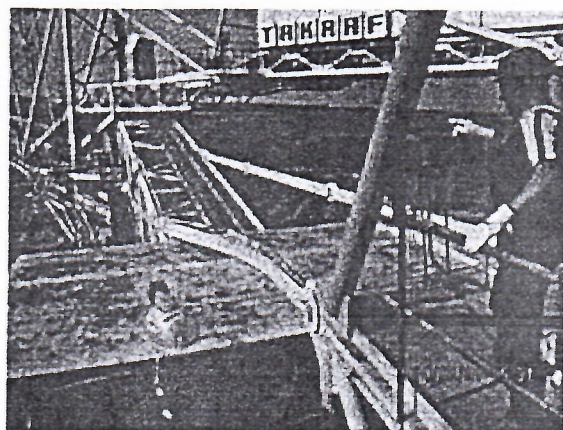
Figure 3.- Appearance of the condition of vital braces of spreader A2Rs - B 5500.55 + BRs before and after the breakdown

a) Appearance of the spreader before the breakdown

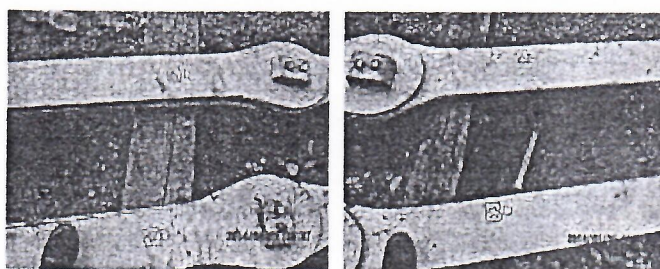
Figure 4.- Appearance of the condition of a number of braces after the breakdown

a) Undamaged braces

b) Undamaged braces

c) Right brace (10 D) with a surface crack

In order to perform the state analysis and integrity evaluation of a brace of the discharge boom, shown in *figure 4c*, at which the surface crack was detected in parent material by visual testing, the following non-destructive tests were performed:

By visual testing [4] surface crack was detected at parent material of one of the braces of the discharge boom, in the near proximity of the butt-welded joint, which was confirmed by penetrant testing, *figure 4c*.
