# The Design – in Faults as a Causes of the High Performance Machines Failures

<sup>1</sup>University in Belgrade - Faculty of Mechanical Engineering

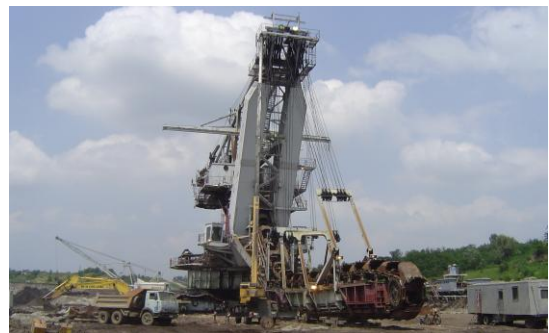
Fig. 2. Bucket chain excavator ERs 1000

BCE ERs 1000, Fig. 2, is in use in open pit mine "Kolubara". During perennial exploitation cracks were observed on the column heads of supporting truss of the counterweight boom (CWB) Fig. 12. These cracks have been weld repaired, but after some time they appear again, being longer and longer.

- Diagnose the cause of cracks occurrence;
- Define the reconstruction design of the truss columns, Fig. 13;
- Verify the reconstructed structure by numerical-experimental analysis, Figs. 14 and 15.
