INTEGRITY ASSESSMENT OF AUTOCLAVES AFTER RECONSTRUCTION PROCENA INTEGRITETA AUTOKLAVA NAKON REKONSTRUKCIJE

Originalni naučni rad / Original scientific paper
UDK /UDC:

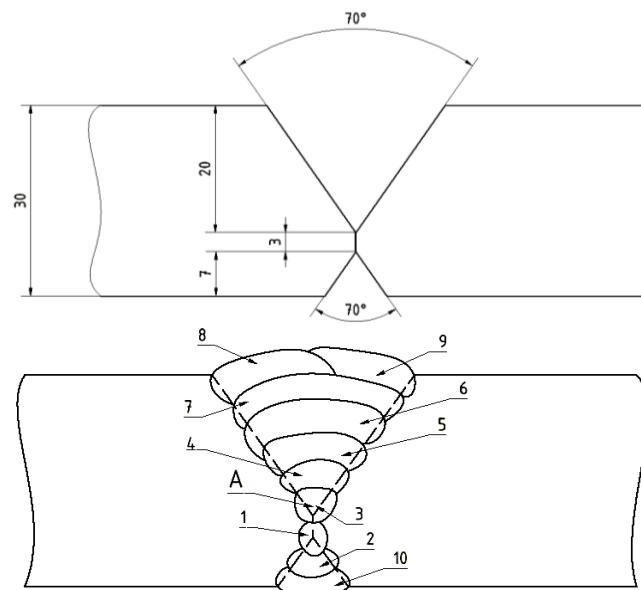
Figure 7. Longitudinal welded joint groove and groove filling plan (material 18 MnMo4-5+NT).

The required welded joint quality of both steels can be obtained by performing appropriate preheating before the welding. For longitudinal and circular joints, preheating temperature was 230 °C for both materials, whereby the longitudinal joints, due to their stress state (~ two times higher than in circular welds), were subjected to stress annealing at 600 °C. Heat treatment was performed in order to reduce residual stresses caused by cold rolling in the manufacturing process of the autoclave shell, and also as heat input during welding.

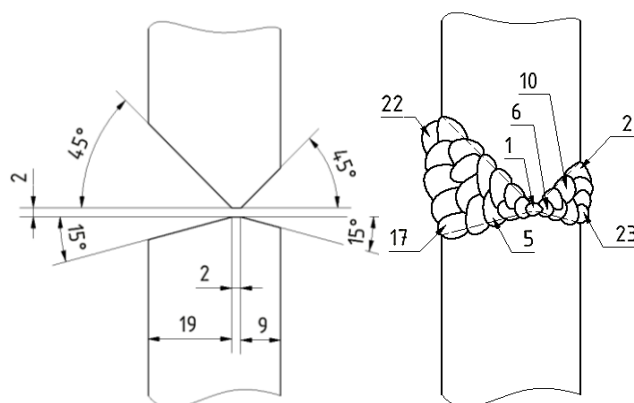
of the new assembly (middle and lower shell segments and bottom lid of 18 MnMo4-5 + NT), and upper autoclave part (steel Altherm 55), as well as the order of filling passes.

Figure 8. Circular welded joint groove and filling plan (Altherm 55 and 18 MnMo4-5+NT steel).
