INSPECTION OF DAMAGE AND RISK ANALYSIS OF CONTAINERS IN A COAL DRYING FACILITY IN EXPLOITATION

Originalni naučni rad / Original scientific paper
UDK /UDC:

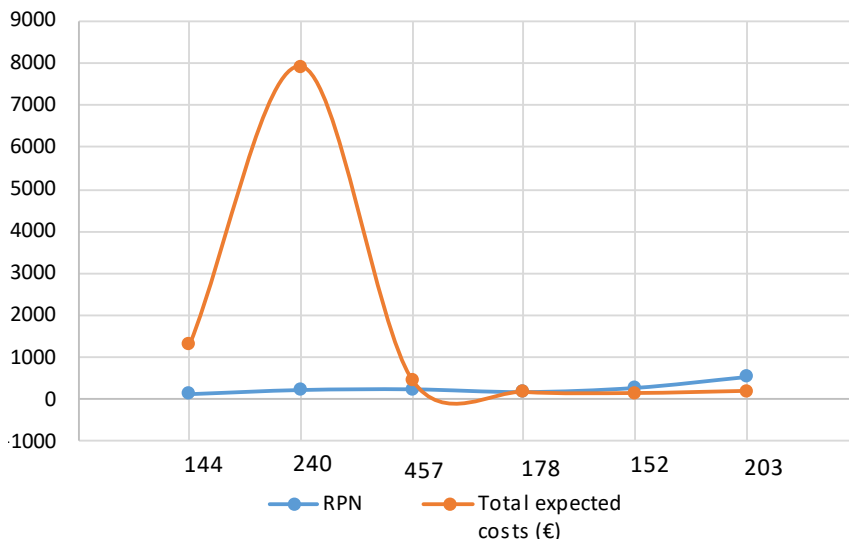
Three values mentioned above do not have the same weight when compared in terms of risk. High RPN value indicates the severity of a certain form of failure, especially when coupled with high probability of occurrence. A comparative review of expected costs and RPNs for 6 different types of failure from Table 3 is shown in Table 4.

As can be seen, Table 4 provides the comparison of RPNs for different failure scenarios, wherein the probability of occurrence (O), severity (S), and detectability (D), are adopted according to AIAG recommendations, /15/. Based on these parameters, Risk Priority Numbers are determined and are shown as a function of failure type in Fig. 3, along with expected costs. As expected, the highest risks, i.e., RPNs were observed in failure types related to cracks, which are the most common causes of failure in pressure vessels.

Figure 3. Comparative display of RPNs and expected costs.
