## Second International Symposium on Risk Analysis and Safety of Complex Structures and Components (IRAS 2023)

# Review of failure analysis of coupling systems on trains

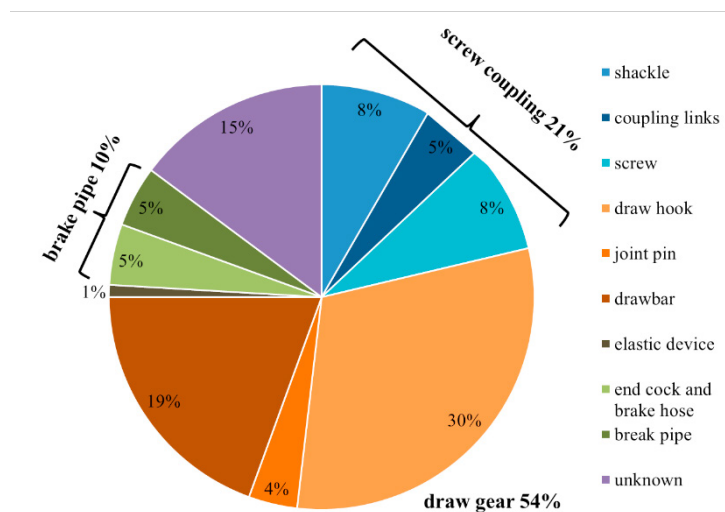
Fig. 3. Distribution of failures in coupling system components

Train breaks apart take place upon a failure of screw coupling or draw gear elements. Additionally, train breaks apart can occur when there are failures of air brake components (brake hose, valve, pipe etc.). The average number of train breaks apart on Serbian railways for freight railway transport of national undertaker "Serbia Cargo" from 2018 to 2020 was 36,4 per year. According to Vukšić Popović (2021) from 2018 to 2020 at "Serbia Cargo", screw coupling elements failed in 21% of train breaks apart, while draw gear elements failed in 54% (Fig. 3). As the screw and coupling link serve as safety elements of the coupling system and are expected to fail before others, their failure rate should be higher.
