**DVANAESTO MEĐUNARODNO NAUČNO – STRUČNO  
SAVETOVANJE  
OCENA STANJA, ODRŽAVANJE I SANACIJA GRAĐEVINSKIH  
OBJEKATA**

**EFFECTS OF MAINTAINING A BUILDING CONSTRUCTED IN THE IMS  
SYSTEM (ŽEŽELJ) WITH AN APPROXIMATE ANALYSIS OF  
HYDRODYNAMICAL SHOCK AND THE ANALOGY WITH LATERAL SOIL  
EXPANSION WITH CAVERN EFFECTS DURING LIQUEFACTION**

**EFFEKTI ODRŽAVANJA OBJEKTA FORMIRANOG U IMS SISTEMU  
(ŽEŽELJ) SA PRIBLIŽNOM ANALIZOM HIDRIDINAMIČKOG UDARA I  
ANALOGIJOM UTICAJA KAVERNI SA BOČNIM ŠIRENJEM TLA KOD  
LIKVEFAKCIJE**

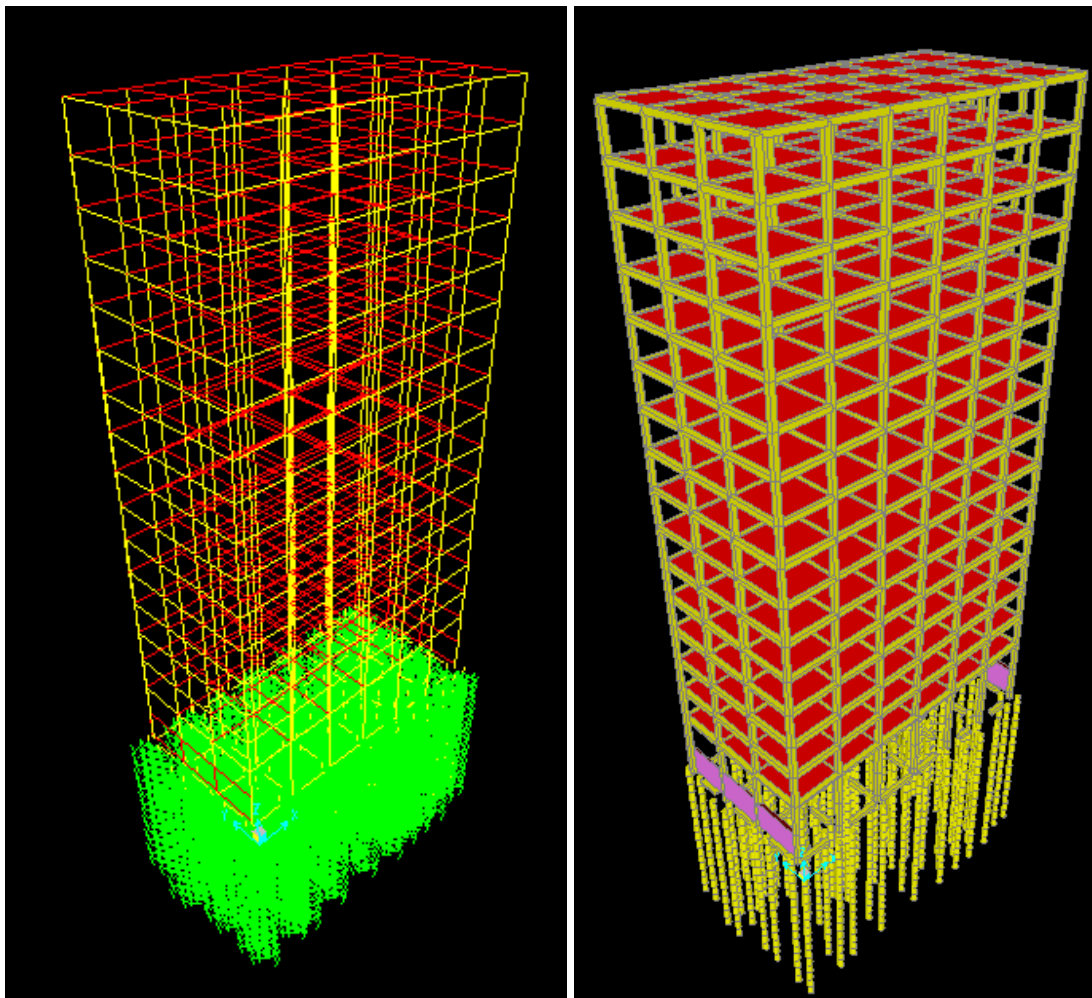
*Figure 11. Simplified model of AV tower.*

In order to check the impact of soil leaching under the basement slab, it is necessary to include piles into the model, whereby it is necessary to simplify the upper structure, due to the limited computer resources at the time. More precisely, the available resources at the time could not support such a complex model, so grills were approximated first. The coffered ceiling grills are presented with solid 6.5 cm thick plates. Instead of the existing grill ribbed ceiling system, solid slab system can be substituted via the command: stiffness modifiers.
