## ANALYSIS OF INSPECTION PLAN OF AIR COOLED HEAT EXCHANGER FOR NEEDS OF MAINTANCE AND SAFETY OF OIL&GAS PLANTS

**Abstract:** The paper shows preparation of inspection plan for air cooled heat exchanger in refinery. The importance of proper inspection, traceable prepared plan of inspection is discussed. The inspection of heat exchanger, according to the presented plan, includes visual testing - internal and external, ultrasound testing and liquid penetrate testing. The inspection plan is essential for maintenance the pressure equipment in refineries and is performed according to API 572 and API 510. The inspection of air cooled heat exchanger shows satisfactorily results.

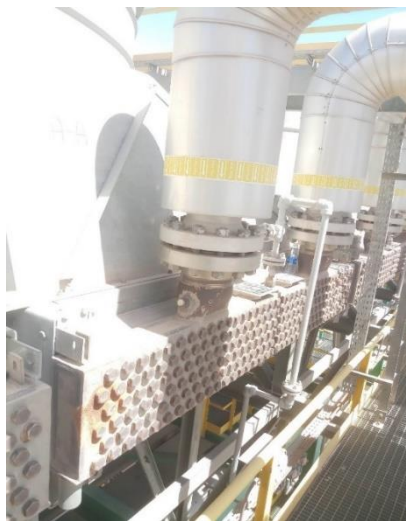
External Metal Surfaces / External Evidence of Corrosion External metal surfaces were found in good condition. Corrosion was not observed on them in time of inspection.

**Figure 1.** Air cooled heat exchanger (view from the front side)

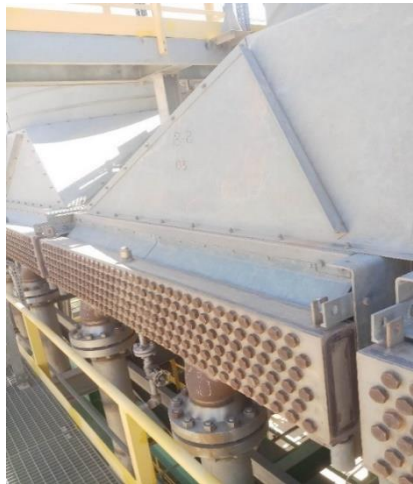
**Figure 2.** Air cooled heat exchanger (view from the back side)

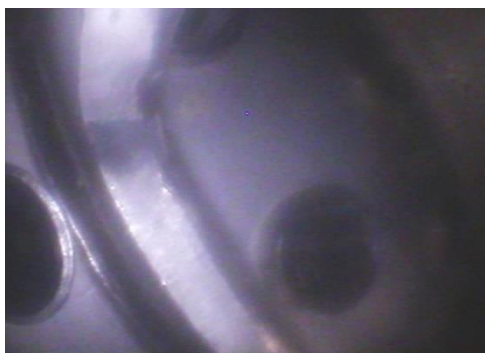
Interior of header (Figure 3) and tubes was found in good condition. Corrosion in them was not observed in time of inspection.

**Figure 3.** Interior of the header was found in good condition in time of inspection

Next external inspection, internal inspection and ultrasonic thicknesses measurements at the same position should be performed within next five years.
